**HealthyLine.com**  
R.D.S. Medical, P.C.  
7510-4th Ave, Ste. 5  
Brooklyn, NY 11209

### Introduction

360° Test Labs has been retained to perform functional testing of a HealthyLine Therapy Mat. A 19" x 31" Therapy mat inset with 1" diameter tourmaline discs in a 11 x 22 grid of approximately 12.5" x 25" was provided. Included was a controller, approximately 3" x 5" x 1" with a power button, temperature setting dial, a two digit LED display and a metal "EMF" contact. The LED normally displays the mat temperature (°C), and displays set-point temperature when the temperature dial is rotated. Two cords exit the controller: a 3 foot cord with a plug for a standard NEMA 5-15R receptacle, and a 30" cord with a plug to mate with the receptacle on the therapy mat.

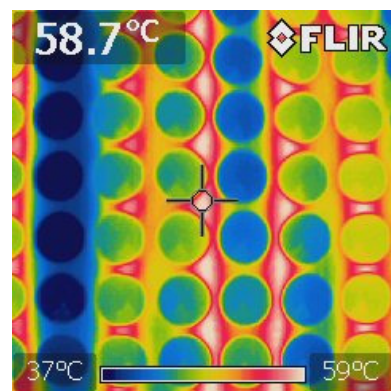
The temperature of the warmest stones was typically about 10°C cooler than the underlying mat, while the cooler stones were about 10°C cooler than the warmest stones.

Figure 6: Underlying mat

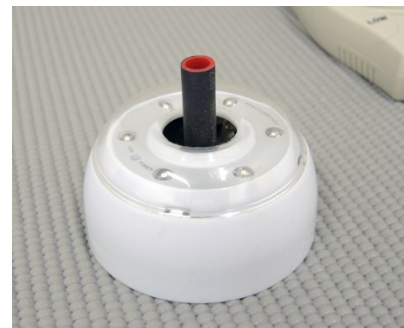
The presence of far infrared radiation was determined utilizing a modified motion detector containing a PIR D203S pyroelectric infrared sensor with a specified spectral response of 5-14μm. The detector was modified by replacing the Fresnel lens with an opaque tube to greatly narrow the sensor field of view. The therapy mat was then placed upon a foam PVC sheet, turned on and set for a temperature of 50°C.

**Figure 8: Modified motion detector**
